Texas Main Street

Design Services: Case Studies from Main
Street Cities

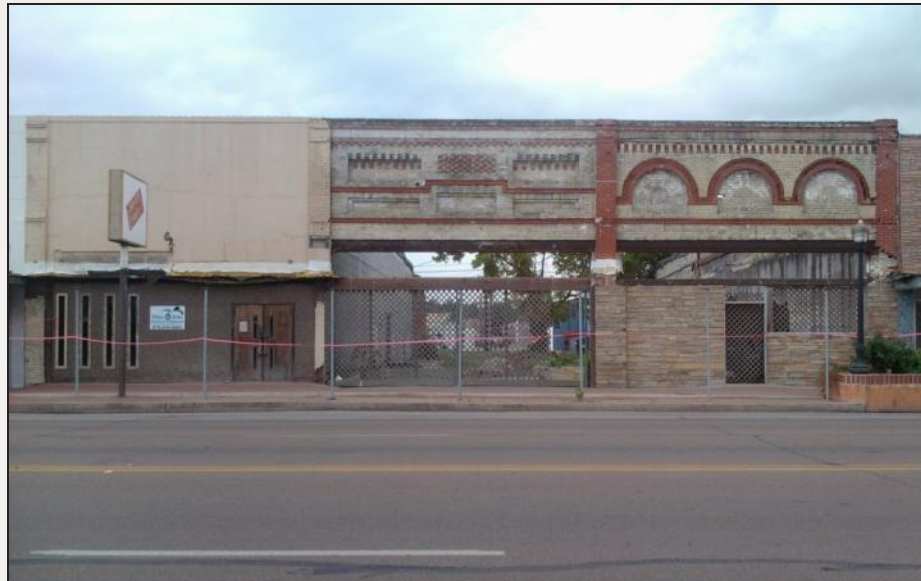
Existing Photograph

- After removal of the slipcover on the far left, inspect the condition of brick and mortar and make repairs as necessary.
- Replace storefronts with wooden storefronts based on the historic photograph.
- Recreate pole-supported canopy seen in the historical photograph.
- Rebuild a structure in the center storefront bay, combining it with the structure on the left for the dining areas for a restaurant. Leave the right storefront bay open air for a patio area.

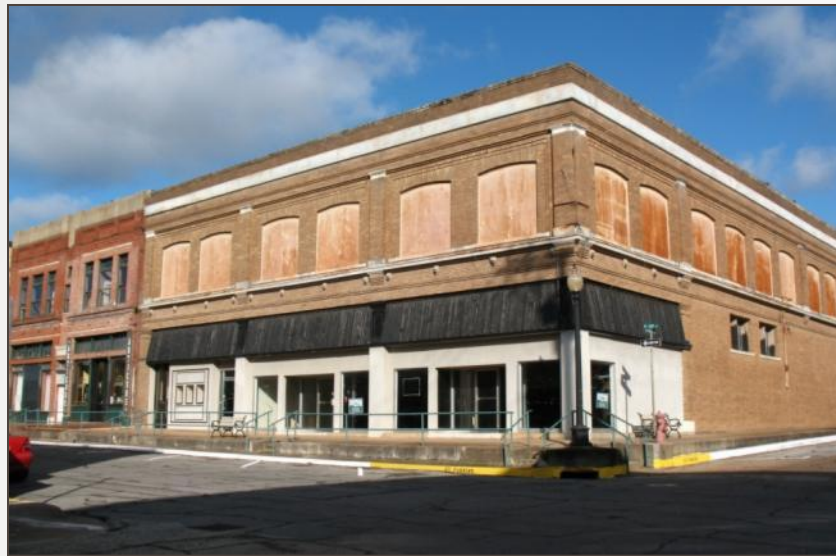
Existing Photograph

- Historic wooden windows are stored in the upper floor of building. Remove the window covers, put the windows back in the window openings and repair historic windows.
- Transom windows are intact and can be seen from the interior. Remove plywood covers and make any needed repairs to the transom windows.
- Remove the modern storefront and reveal cast iron columns. Rebuild wooden storefronts based on historical photographs.
- Rebuild a tie rod supported canopy.

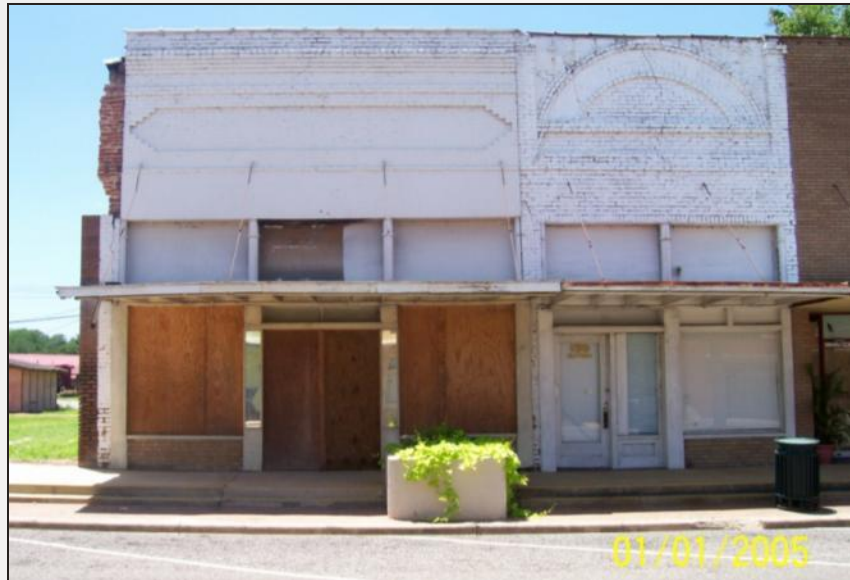
Existing Photograph

- A building was demolished on the left. Prior to any cosmetic changes, inspect this party wall for structural stability and ensure its impenetrability to water.
- Cast iron columns can be seen at the top of the storefront. Remove coverings to reveal columns all the way down to the ground.
- Recreate a historically appropriate wooden storefront.
- Paint the building façade an earth tone color similar to the original brick.
- Place signage in the sign frieze area. Sample signage was rendered.

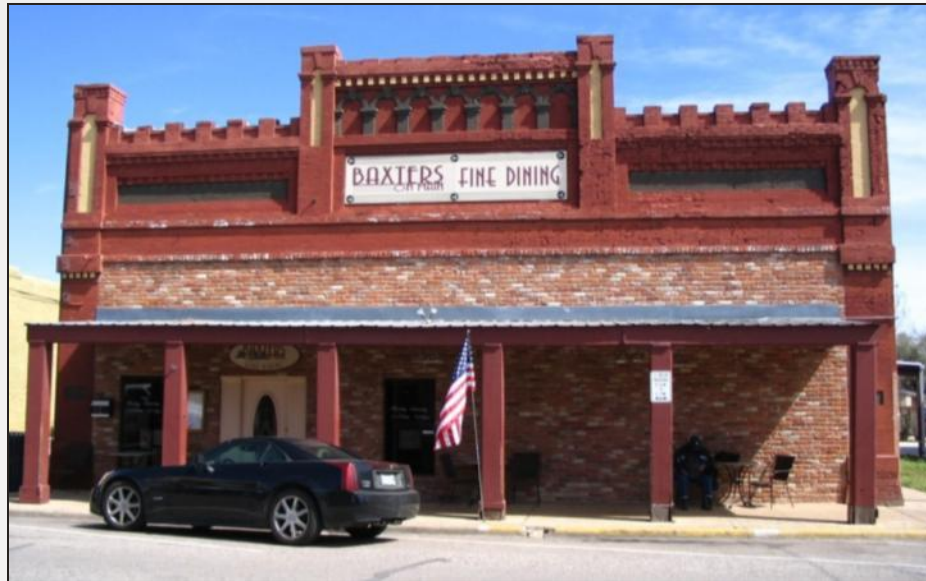
Existing Photograph

- Replace the bricked-in façade with period appropriate wooden storefront.
- Recreate the transom windows above canopy.
- Replace the existing column canopy supports with more slender poles.
- Consider signage that reinterprets the “dry goods” and “groceries” signs shown in historical photographs.

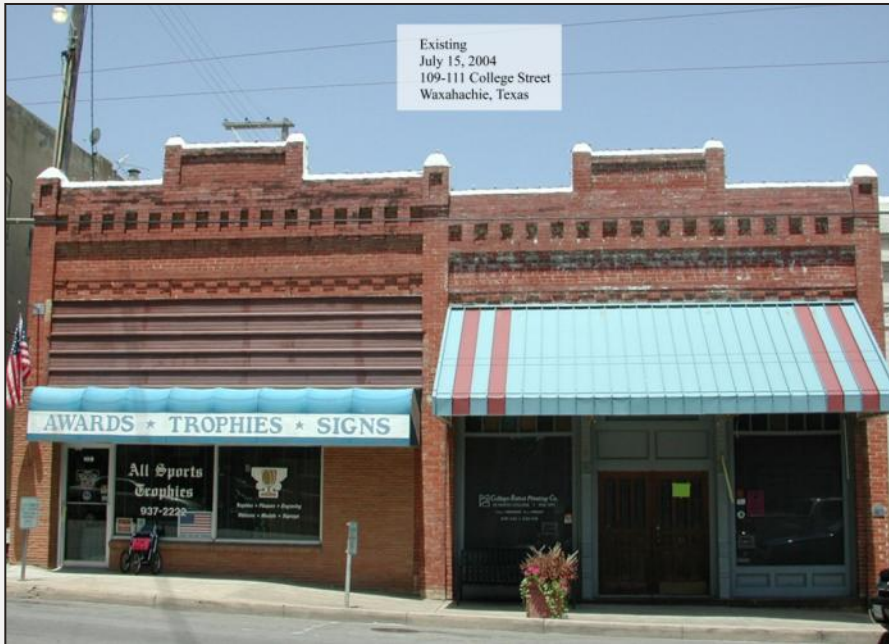
Existing Photograph

- Remove the slipcover over the transom windows on the left building and repair them.
- For both buildings, remove the existing awnings and replace them with ones that will showcase the stained glass transom windows.
- Rebuild the storefront on left building to be more historically appropriate. Use the storefront on the right as guidance. Differentiating the storefronts through colors is recommended.

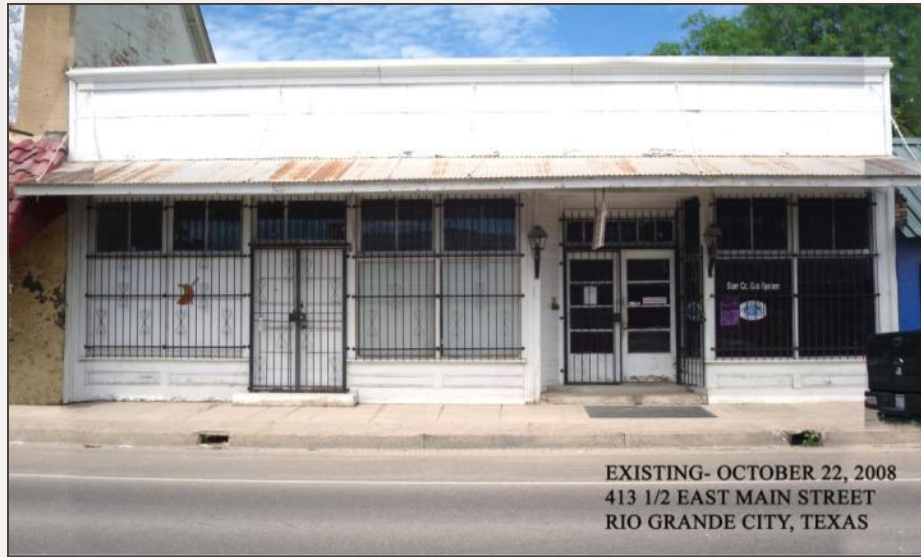
Existing Photograph

- Retain and repair the existing canopy.
- Remove the metal bars from the windows and doors to increase pedestrian friendliness.
- Repaint the building using a red for the pressed metal on the upper façade (to mimic brick), and use cream and brown for the wooden storefront trim.
- Add signage for “Starr County Gas Company” on the windows on either side of the main entrance.

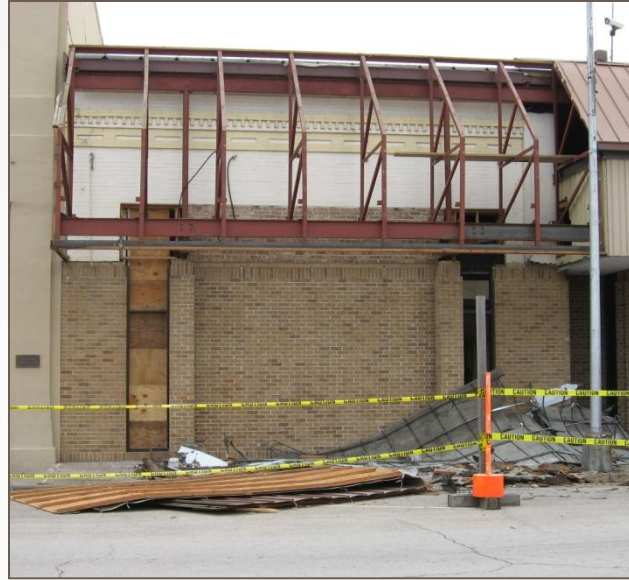
Existing conditions under slipcover

- Remove the brick slipcover and mansard style metal canopy.
- Following the removal of the brick slipcover, inspect the condition of the brick and mortar and make repairs as necessary, taking care to match the color and composition of existing mortar.
- Recreate the tie rod canopy, wood storefront, and transom windows using traditional proportions.

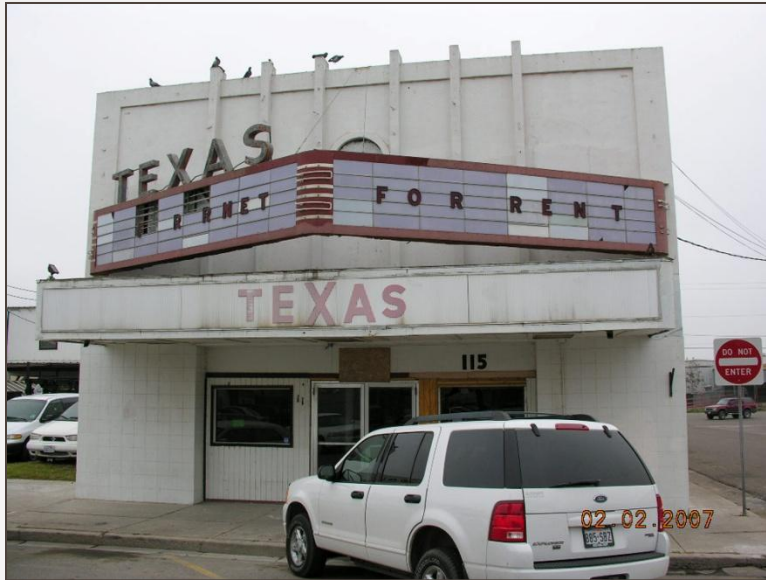
Existing Photograph

- Remove the upper marquee and repair the lower marquee.
- Repaint the façade, including the upper façade's decorative effects that are seen in the historic photograph.
- Restore the neon "TEXAS" letters & the strips of neon on the upper façade.
- Tile the storefront in the spirit of the Art Deco style using black and white tiles and add decorative detailing to the doors.

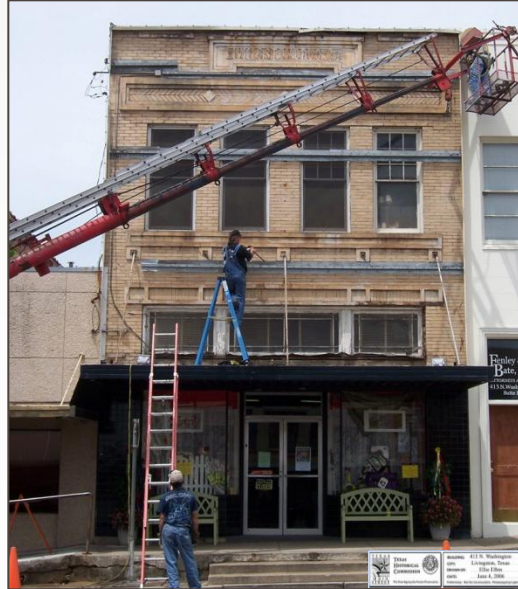
Existing conditions under slipcover

- After the removal of the metal slipcover, inspect the condition of the brick and mortar and make repairs as necessary, taking care to match color and composition of the existing mortar.
- Consider rebuilding parapet as it appears in the historical photographs.
- Return the windows to their original configuration. Replace the two right, upper windows with one-over-one sash windows.
- Consider replacing the current doors with wooden doors.

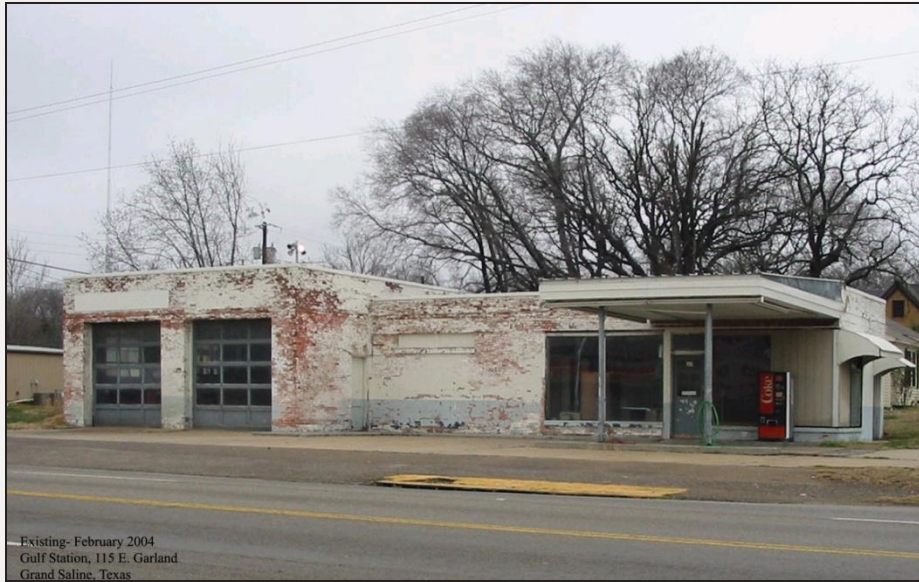
Existing Photograph

- Retain the original architecture of the building. Reopen the glass window on the right corner.
- Inspect condition of brick and mortar. Clean brick using gentlest means possible and make repairs as necessary, taking care to match the color and composition of existing mortar when repointing.
- Repaint the building using colors that were historically used on Gulf Stations.
- Consider placing antique gas pumps under canopy.

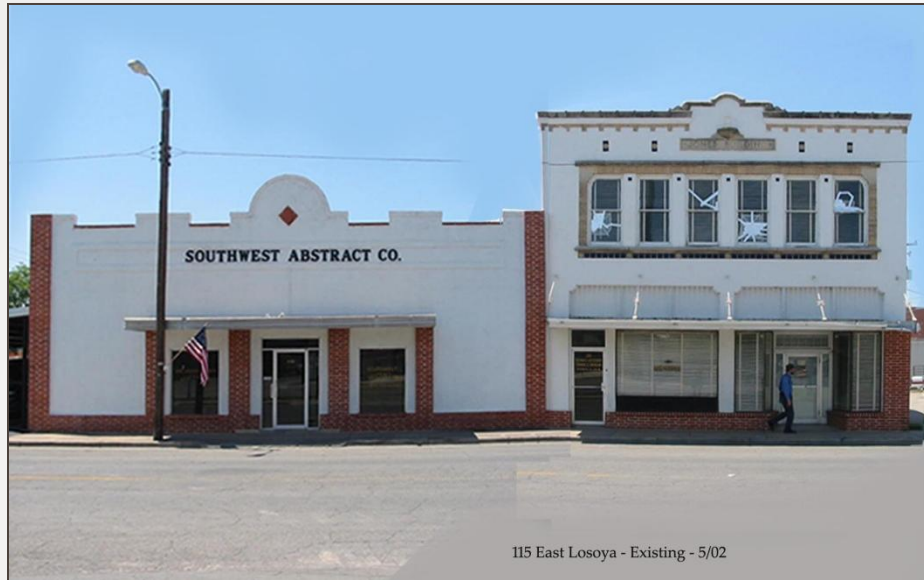
Existing Photograph

- Use coordinating color schemes for each adjacent building to differentiate them from each other.
- Highlight the architectural details, such as the banding along cornice, the sign frame, and the canopies, with contrasting paint colors.
- Replace the broken windows on the second story of the right building.

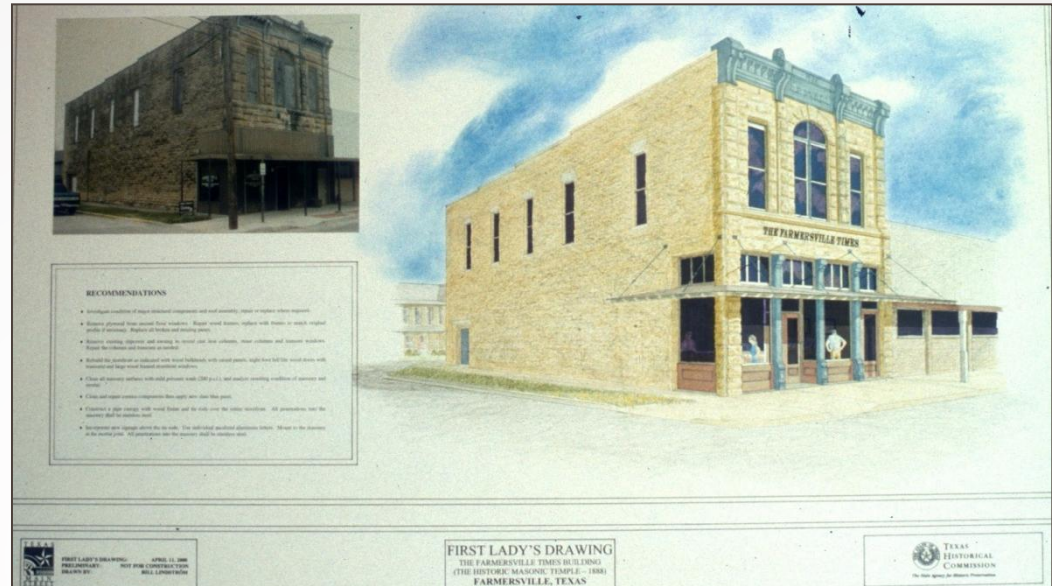
Rendering

- Remove the slipcovers over the lower portions of the façade and gently clean the stone to restore original appearance.
- Restore the transom windows and second story windows.
- Restore the storefront including columns, bulkheads and tie rod canopy.

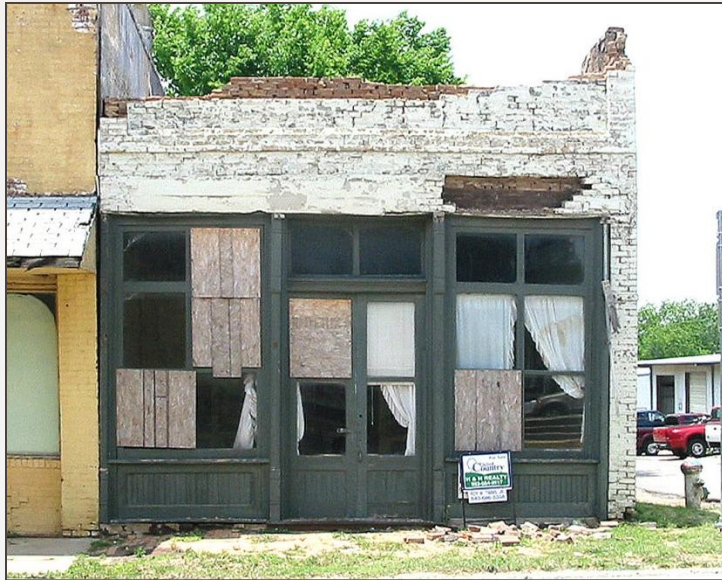
Existing Photograph

- Gently the clean brick to remove the white paint. Rebuild the portion of the parapet that collapsed.
- Replace the broken panes of glass in the storefront.
- Accent architectural features, such as the columns, doors and window frames, with contrasting paint colors.

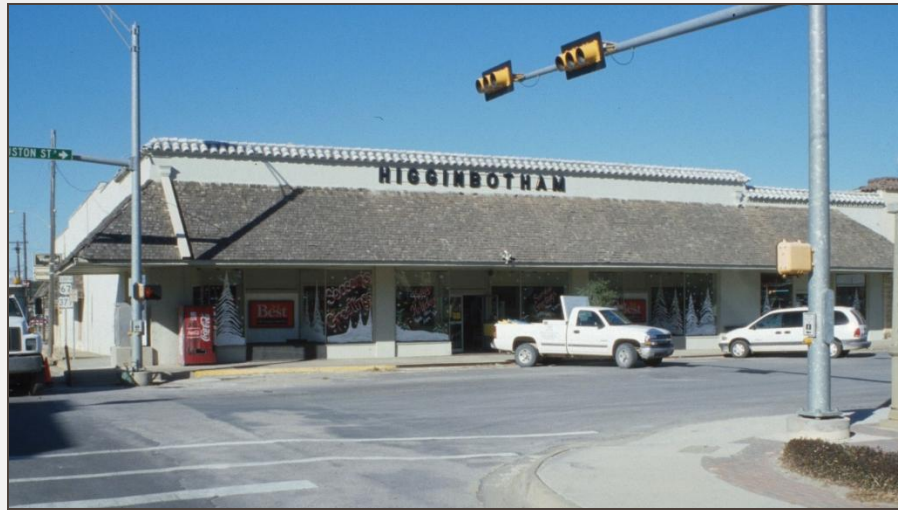
Existing Photograph

- Remove the shingled awning and assess condition of the façade beneath, taking care to preserve as much original architectural detail as possible.
- Repair transom windows as necessary and recreate the tie rod supported canopy.
- Repaint the building using a neutral color palette to highlight architectural details.

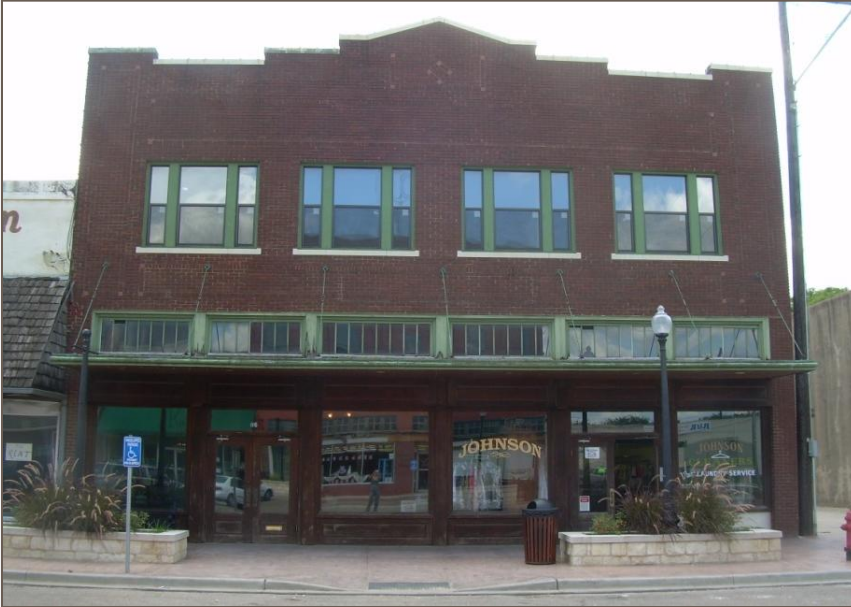
Existing Photograph

- Repair and repaint, rather than replace, the transom windows and wooden storefront. Maintenance issues can be resolved without considering replacing the storefront with rock, or the transom windows with vinyl windows. Simple repairs and a coat of paint are a long lasting, cost effective solution.
- Owners requested new color schemes. The color scheme ties the upper story windows with the transom windows and storefront below, highlights architectural details and coordinates with the brick.

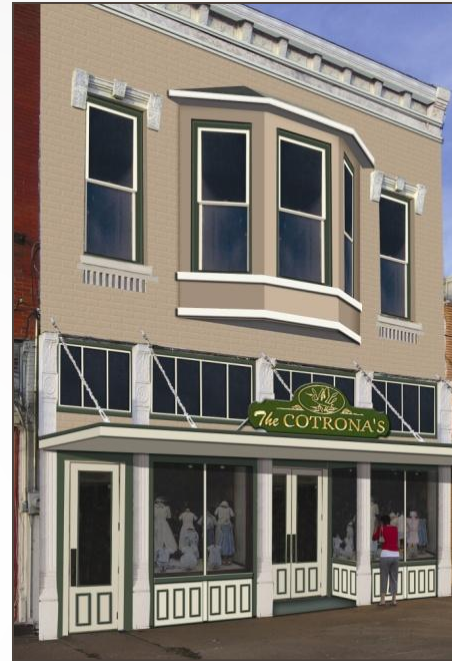
Rendering

- Reveal, clean, repair, and repaint the cast iron elements on façade.
- Restore the transom windows and repair the existing canopy, rather than recreating the canopy seen in historical photo.
- Recreate the bay window on the second story, and the traditional storefront on the first story.
